**Case Study:**  
Perth, WA

## Investigation finds after cooler, fuel pump and injector issues

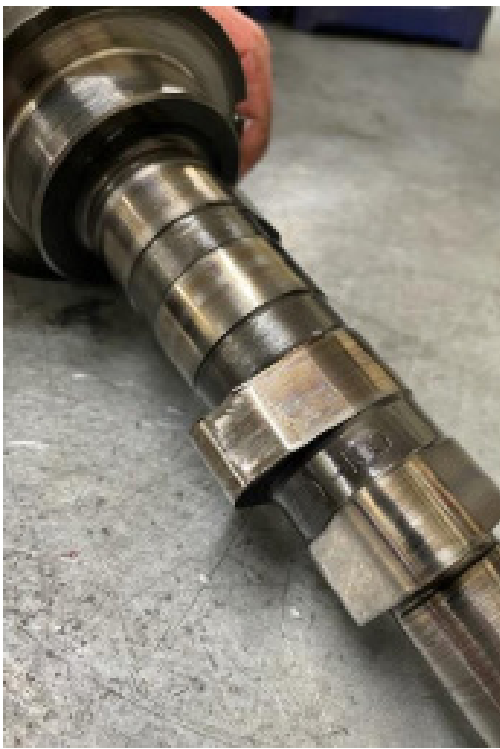
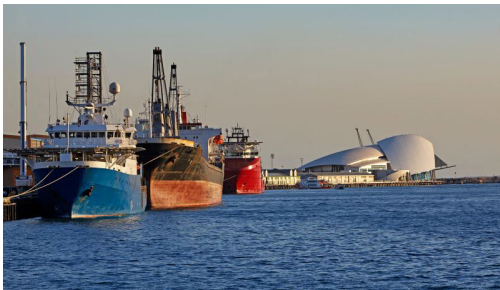
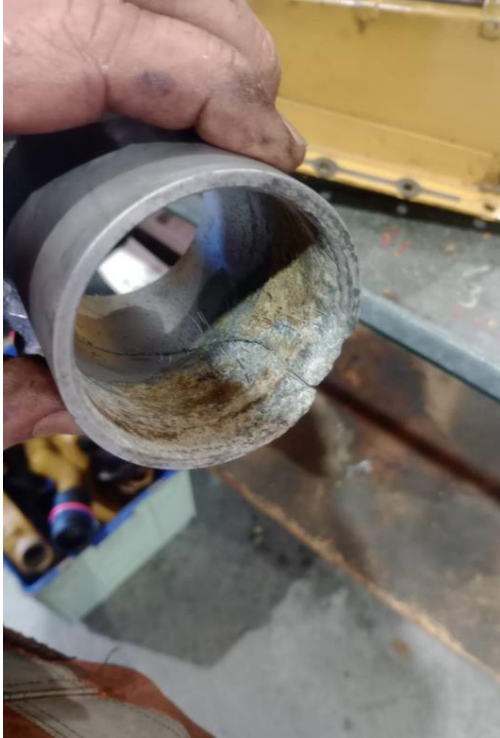
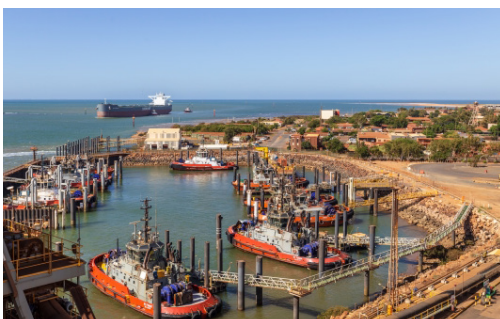
In pulling out the injectors and undertaking a borescope inspection, we observed light corrosion inside the liner walls. We eventually found a cracked aftercooler adapter, which had been pulling in water. Additionally, one of the fuel pumps that wasn't operating properly had severe cam lobe wear and failed testing; and all injectors were in need of replacing.

After the investigation, we requoted to repair or replace everything we had found and the client subsequently decided to remove all of the coolers off the engine, a variation of the scope that required us to provide more man power to meet timescale demands.

Once all the coolers were serviced, they were pressure tested, returned to the vessel, installed and a successful sea trial carried out.
